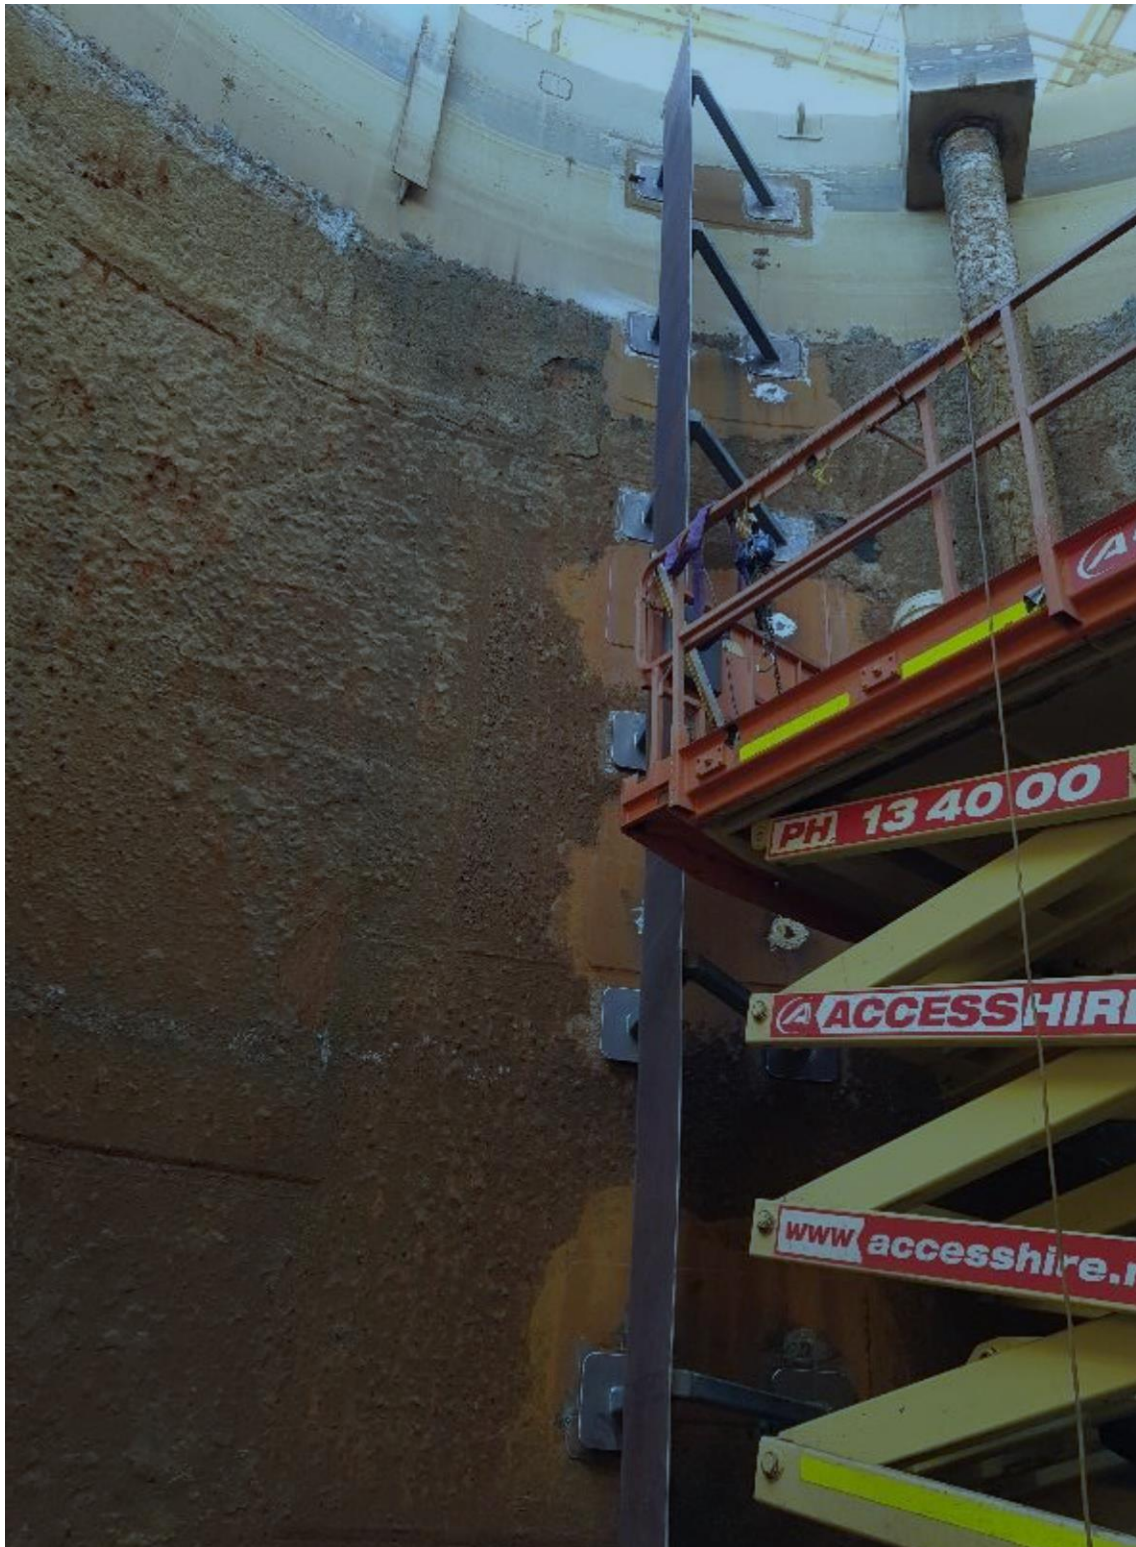
*(Figure 3: Replacement baffle installed in tank prior to completion of water blasting and painting. Note the extensive corrosion on the tank wall)*
