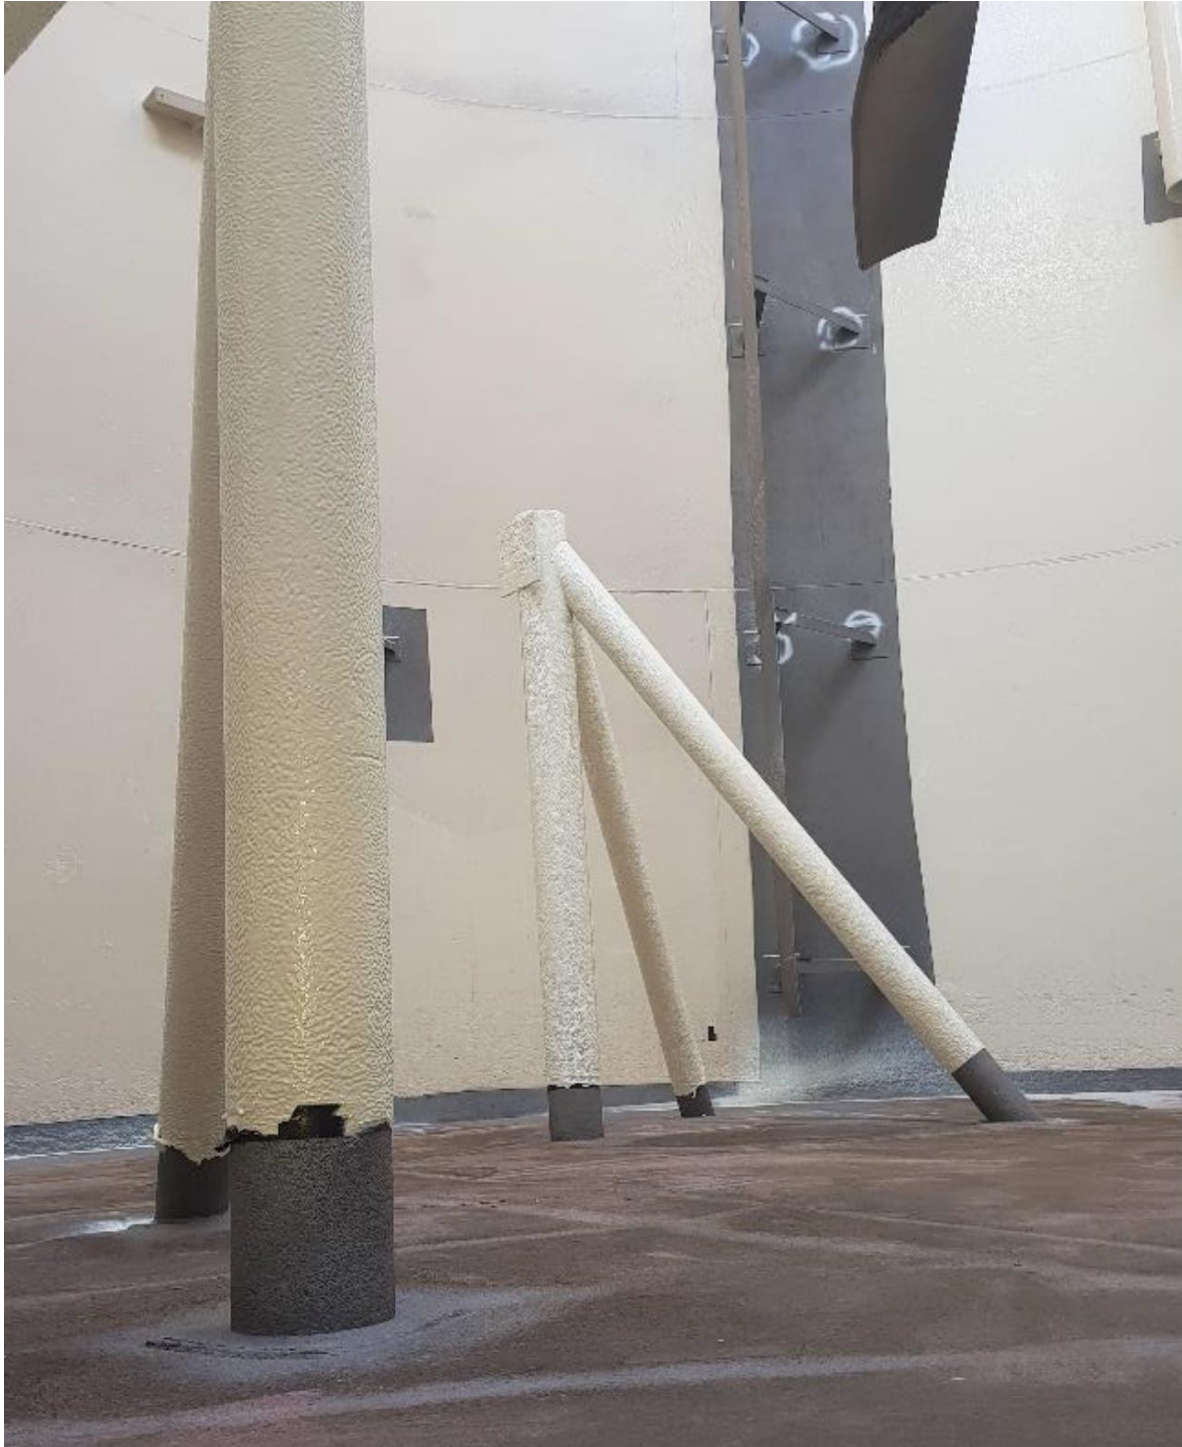
(Figure 4: Tank internal painting partially completed.)
