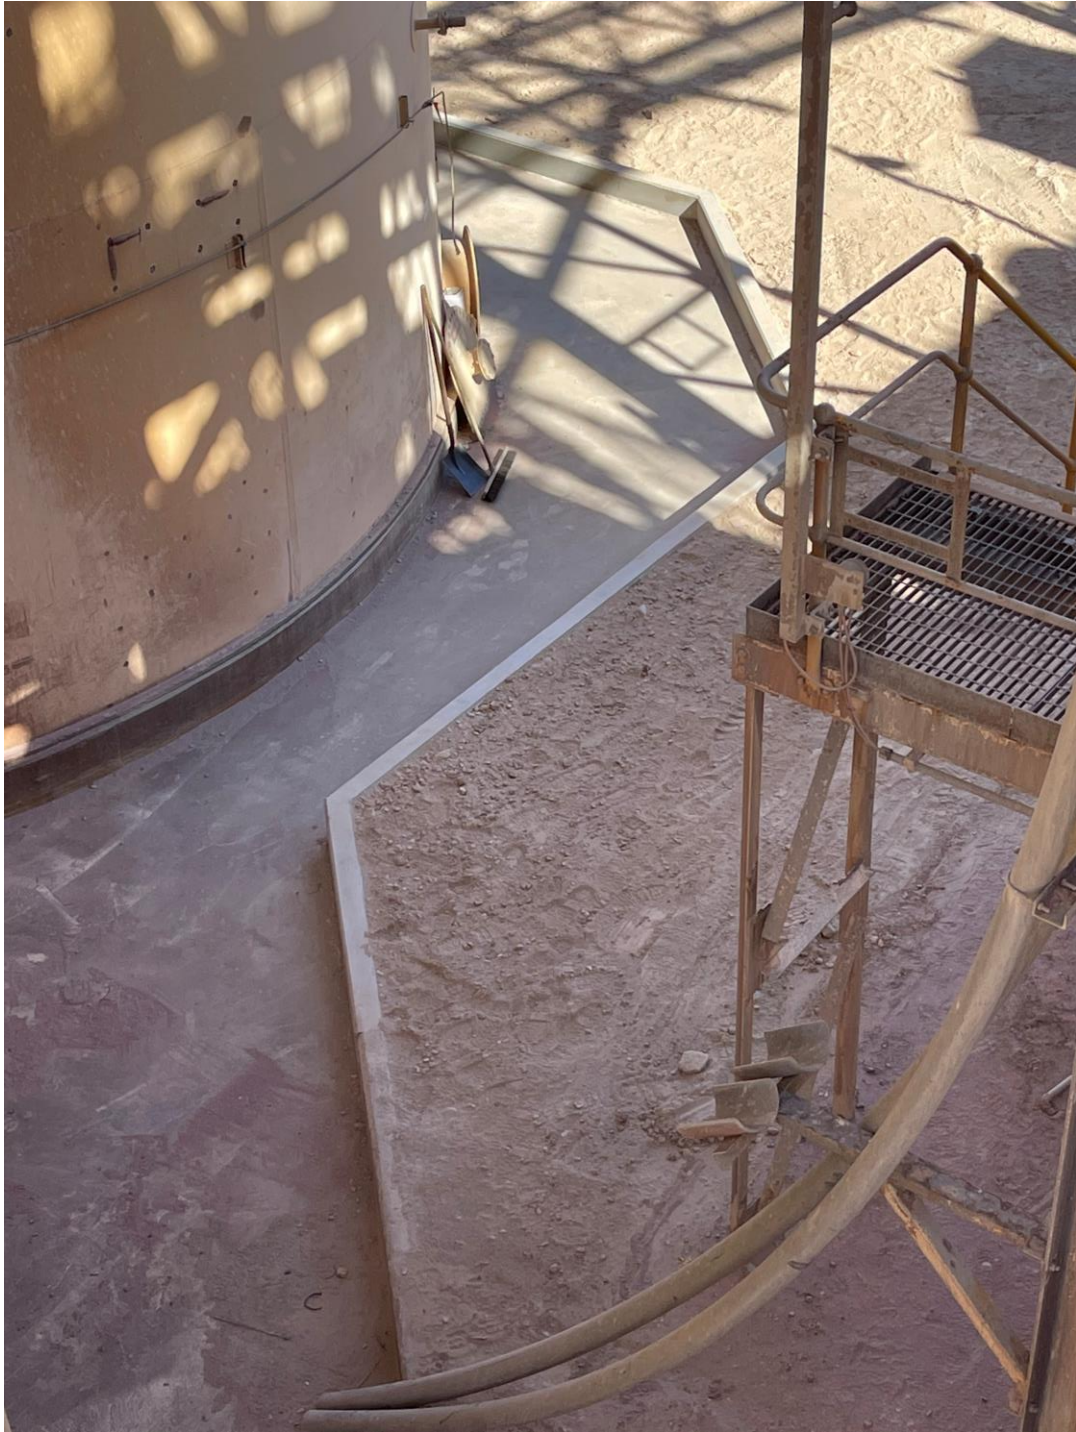
*(Figure 3: Completed concrete repairs to the tank bund walls - view facing north east.)*
