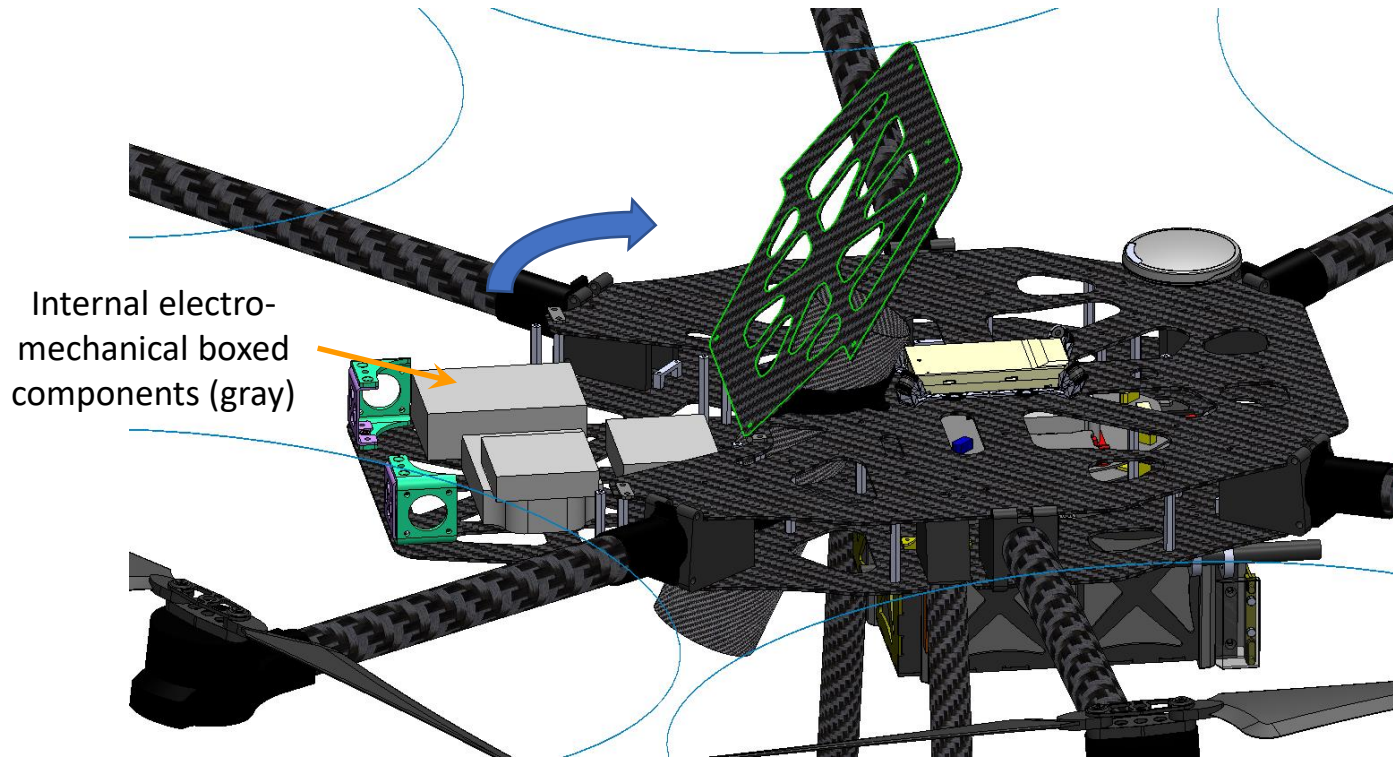
FIG. 4B

Six thumb screws removed and vehicle "hood" is rotated up and back on hinges to allow easy access the critical electro-mechanical components inside.
