ERO
COPPER

Vermelhos, Near-Mine Exploration

Q1 2019 Exploration Update

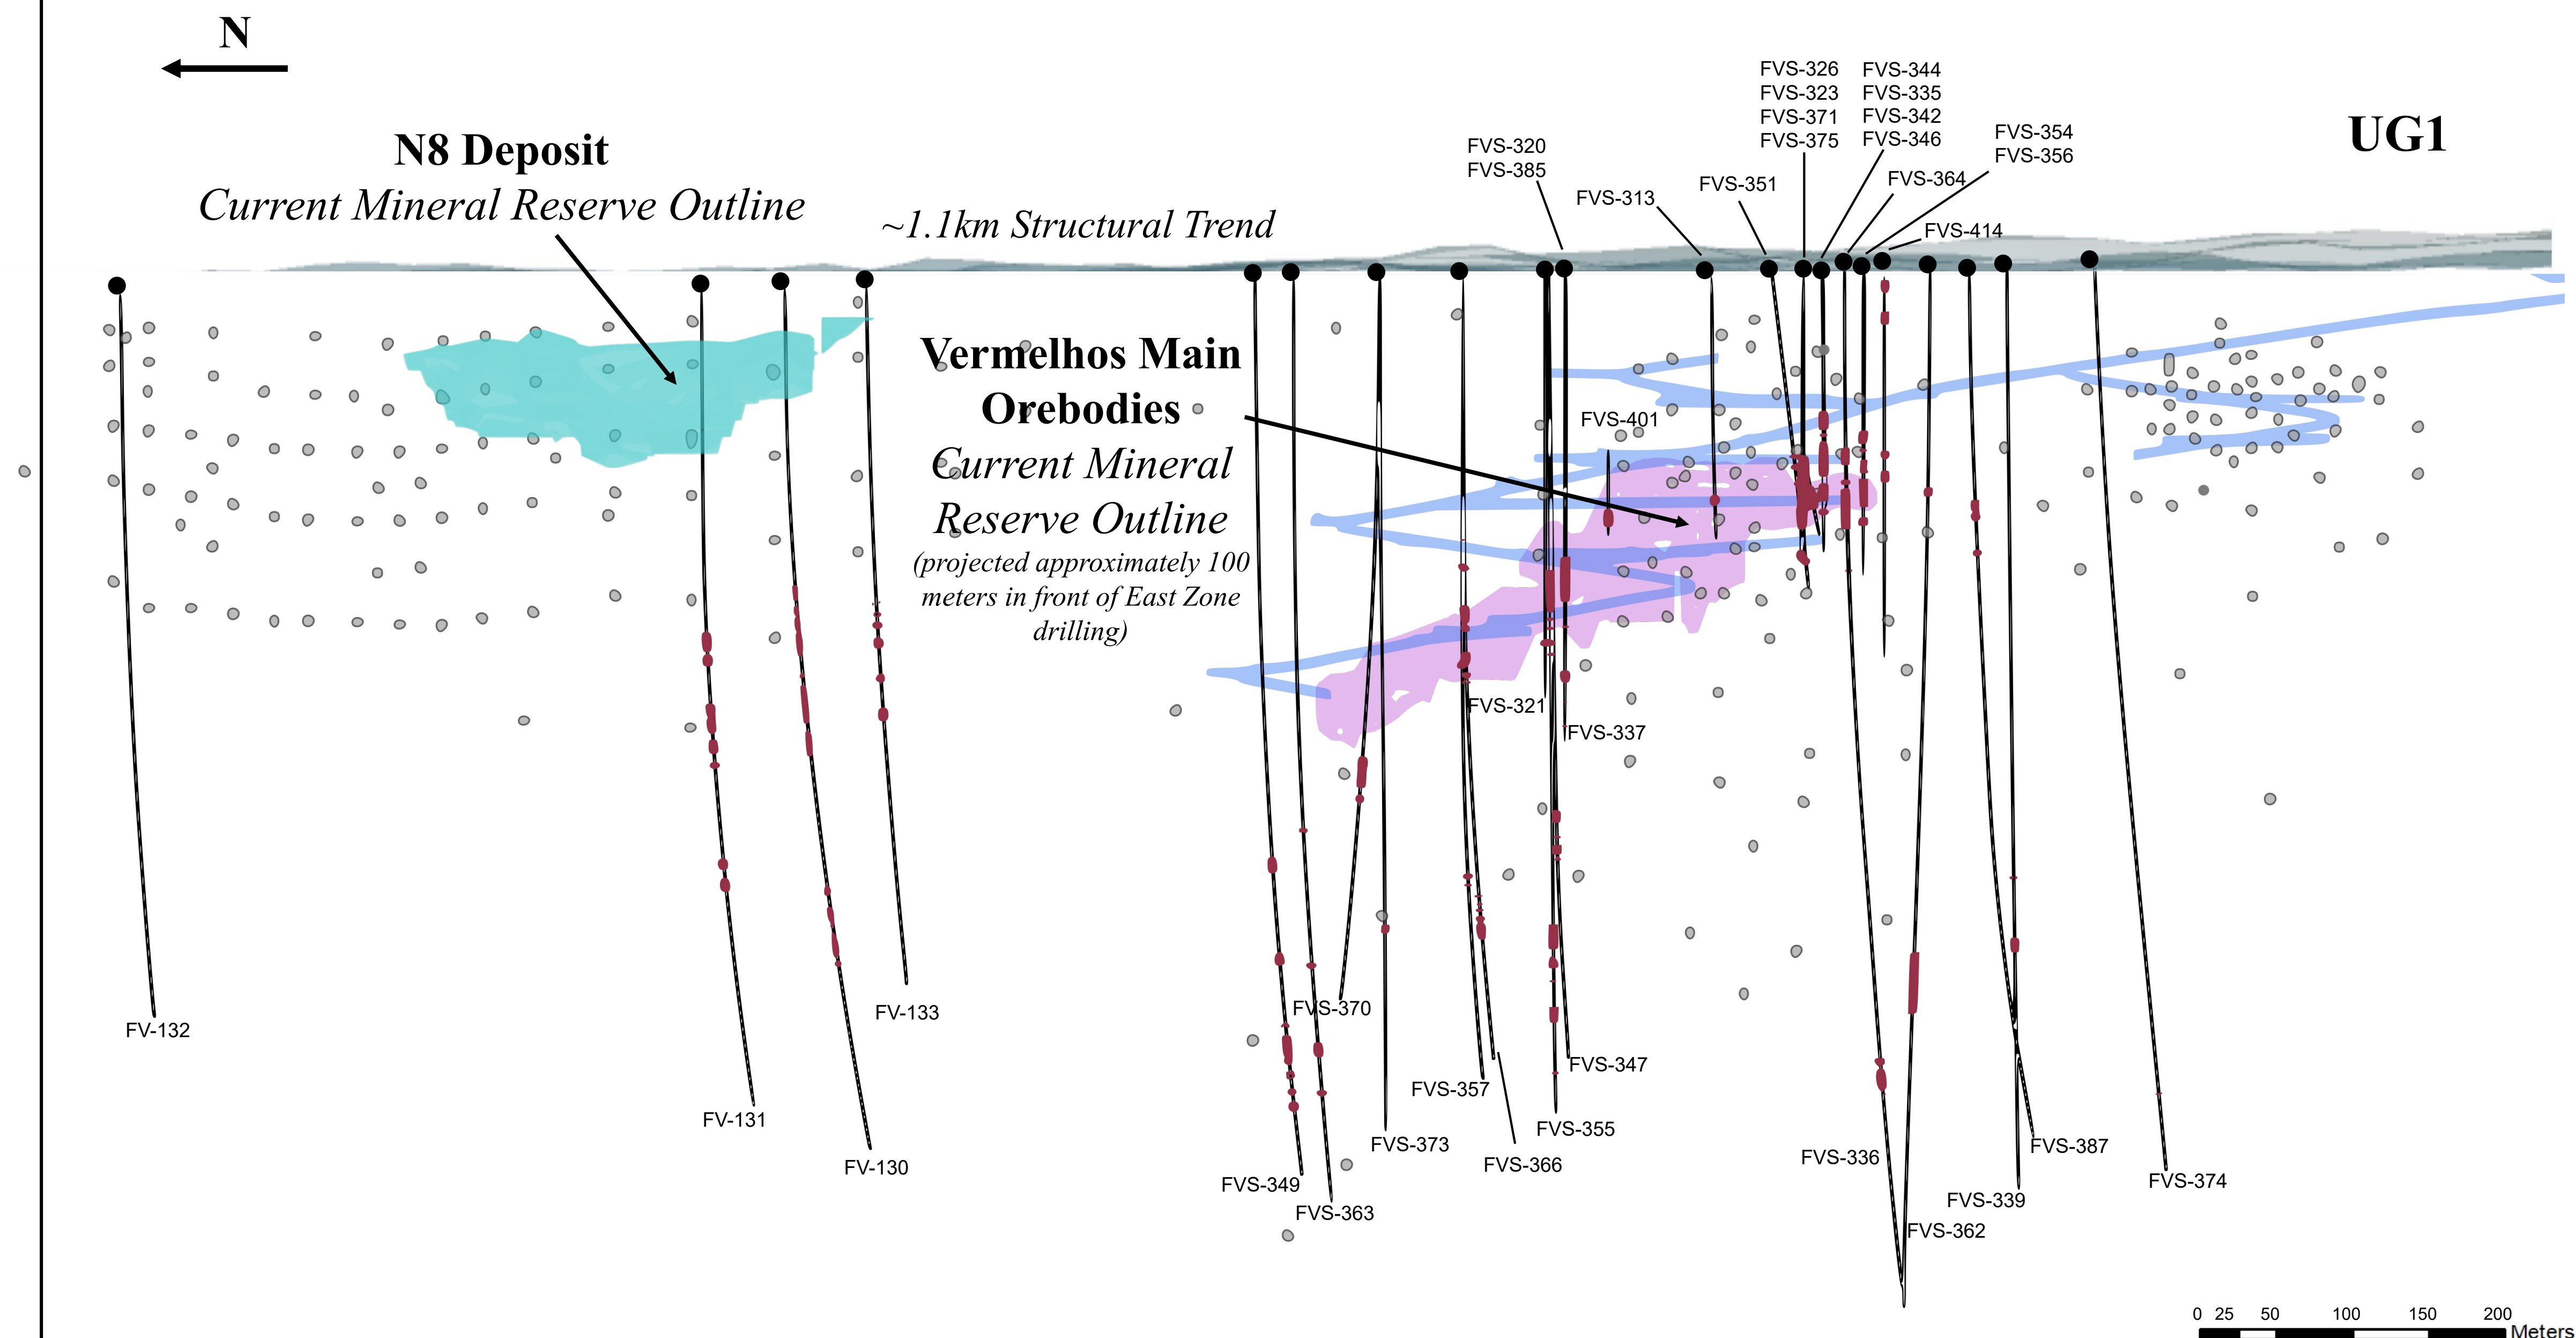
Figure 1

Vermelhos Main Orebodies
Current Mineral Reserve Outline

Interpreted East Zone Boundary Limits

Special Note: Vermelhos East Zone projection shown to demonstrate future area of exploration within the Vermelhos District. The projection is based on data compilation work which includes review of geological controls, structural analysis and copper mineralization identified during the Company's technical programs. The interpretation and boundary limits do not imply continuity of mineralization, or actual thickness of mineralization that has yet to be defined. For additional scientific information related to the Vermelhos Mine, please refer to the Company's Vale do Curaçá Property Technical Report dated October 17, 2018.

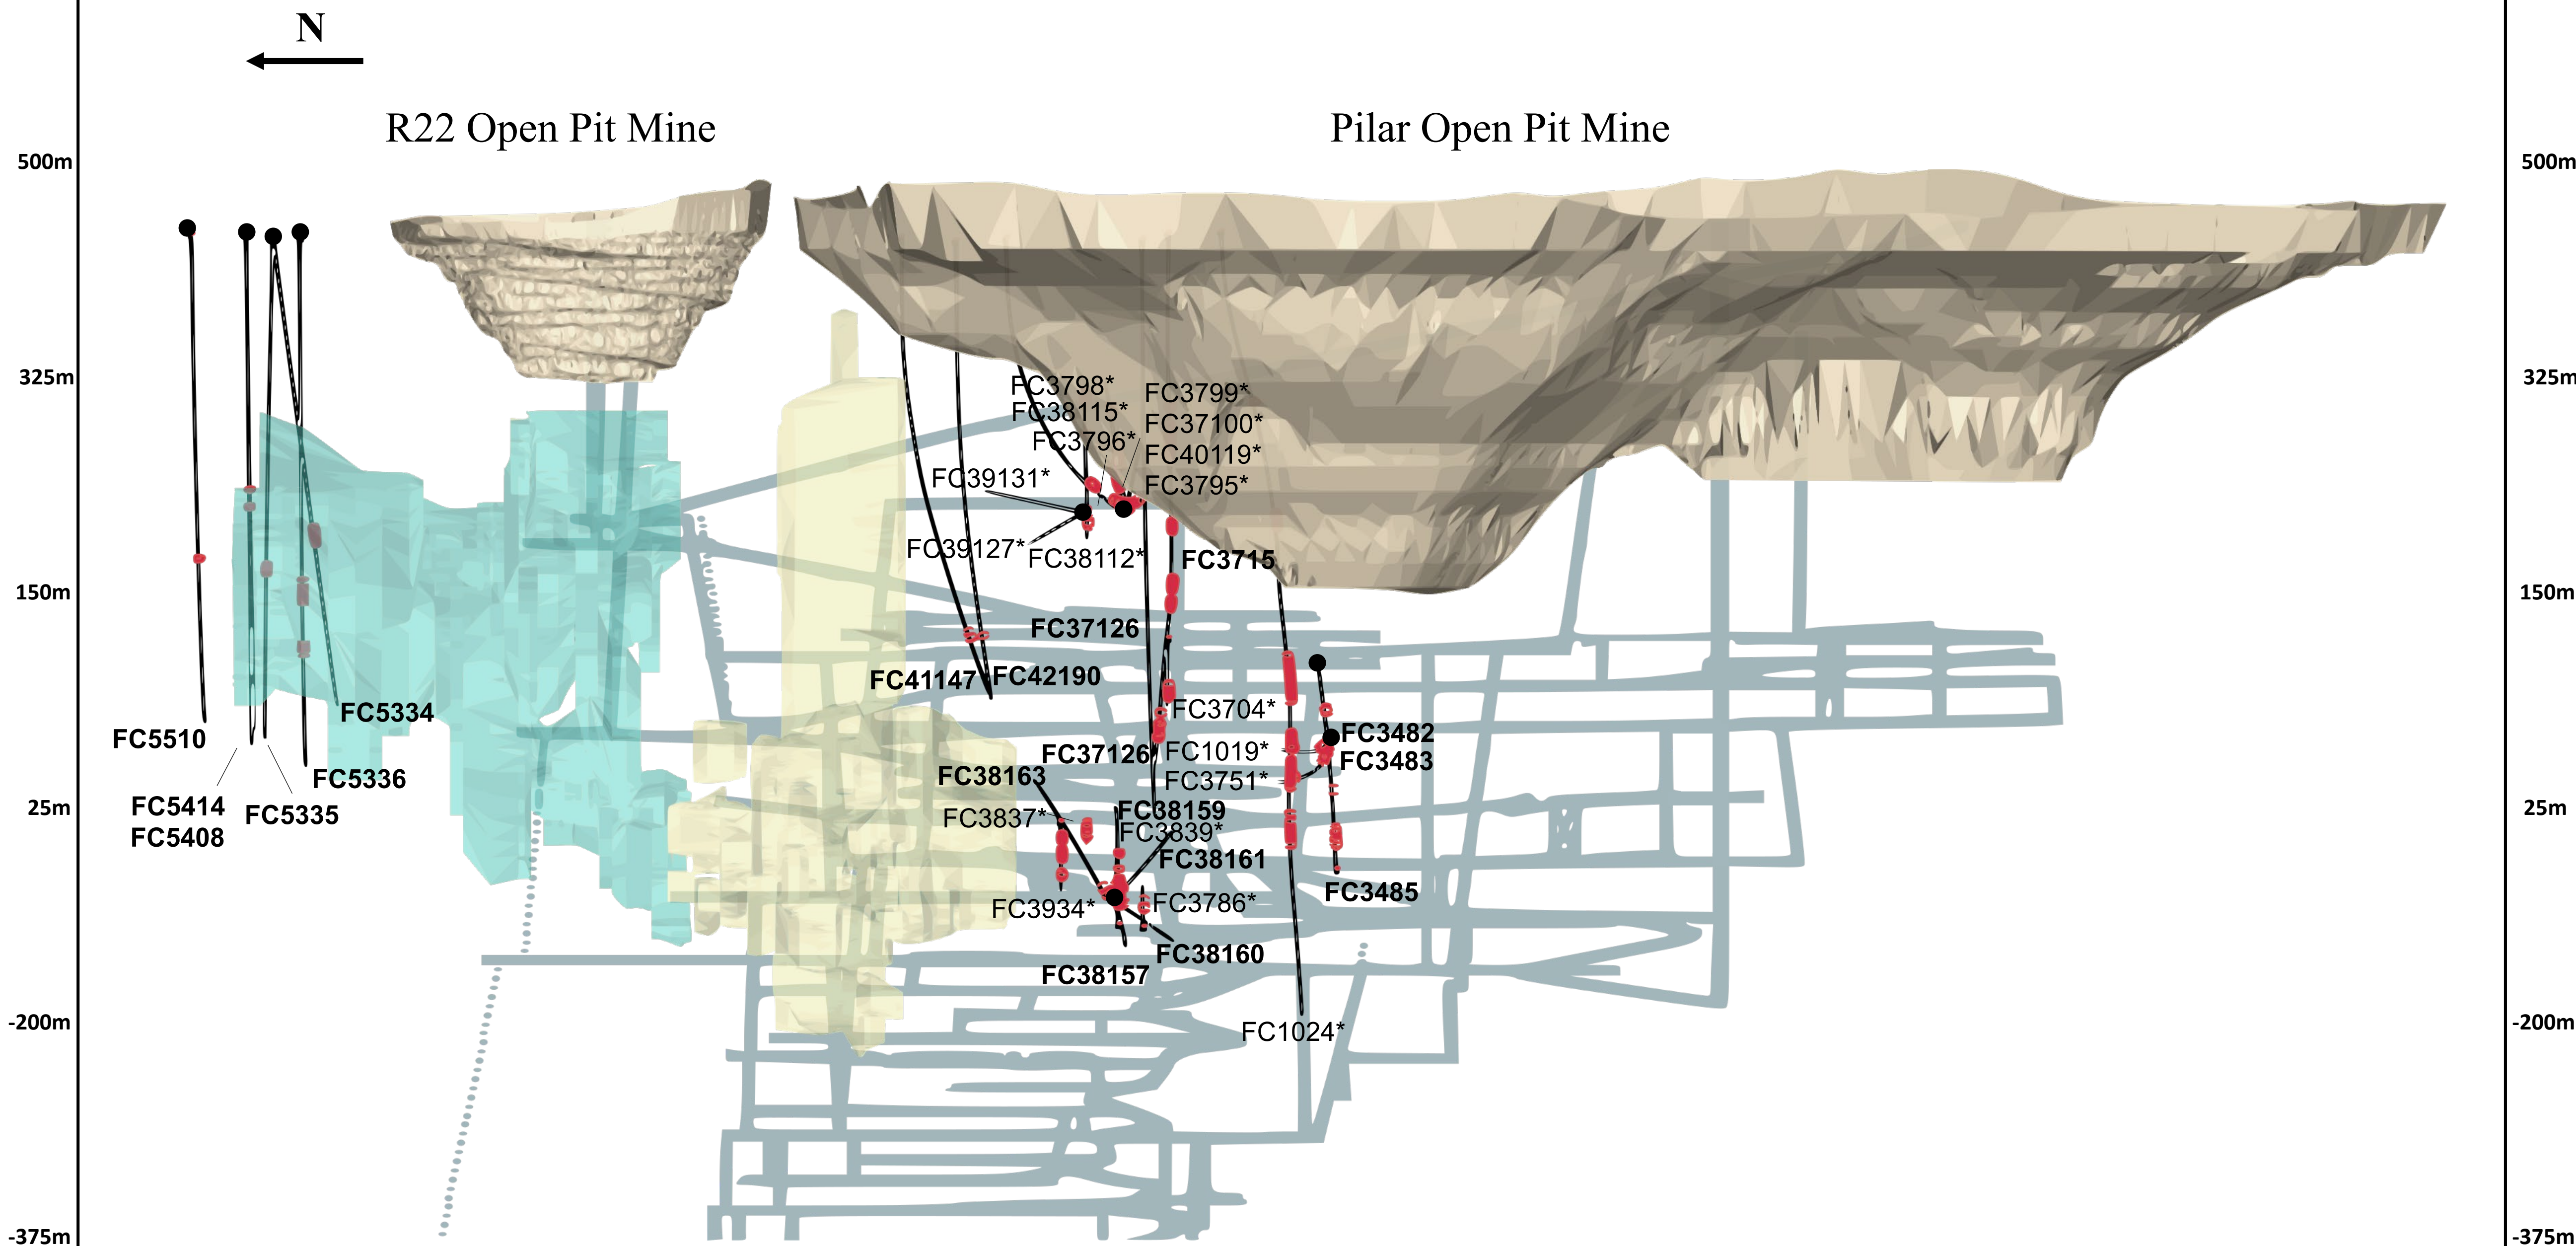
Figure 3

West Limb, North-South Long Section

Extent of West Limb intercepts shown in cross-section demonstrate future area of exploration within the Pilar Mine and are shown for discussion and ease of interpretation only. The extended area is based on drill data and review of geological controls and structural analysis identified during the Company's technical programs. The interpretation and lateral extent shown does not imply continuity of mineralization, or actual thickness of mineralization that has yet to be defined. For additional scientific information related to the Pilar Mine, please refer to the Company's Vale do Curaçá Property Technical Report dated October 17, 2018. Section numbers are indicated in the first two numerical digits of each Hole ID. Each section is 45 meters apart in a north-south direction.

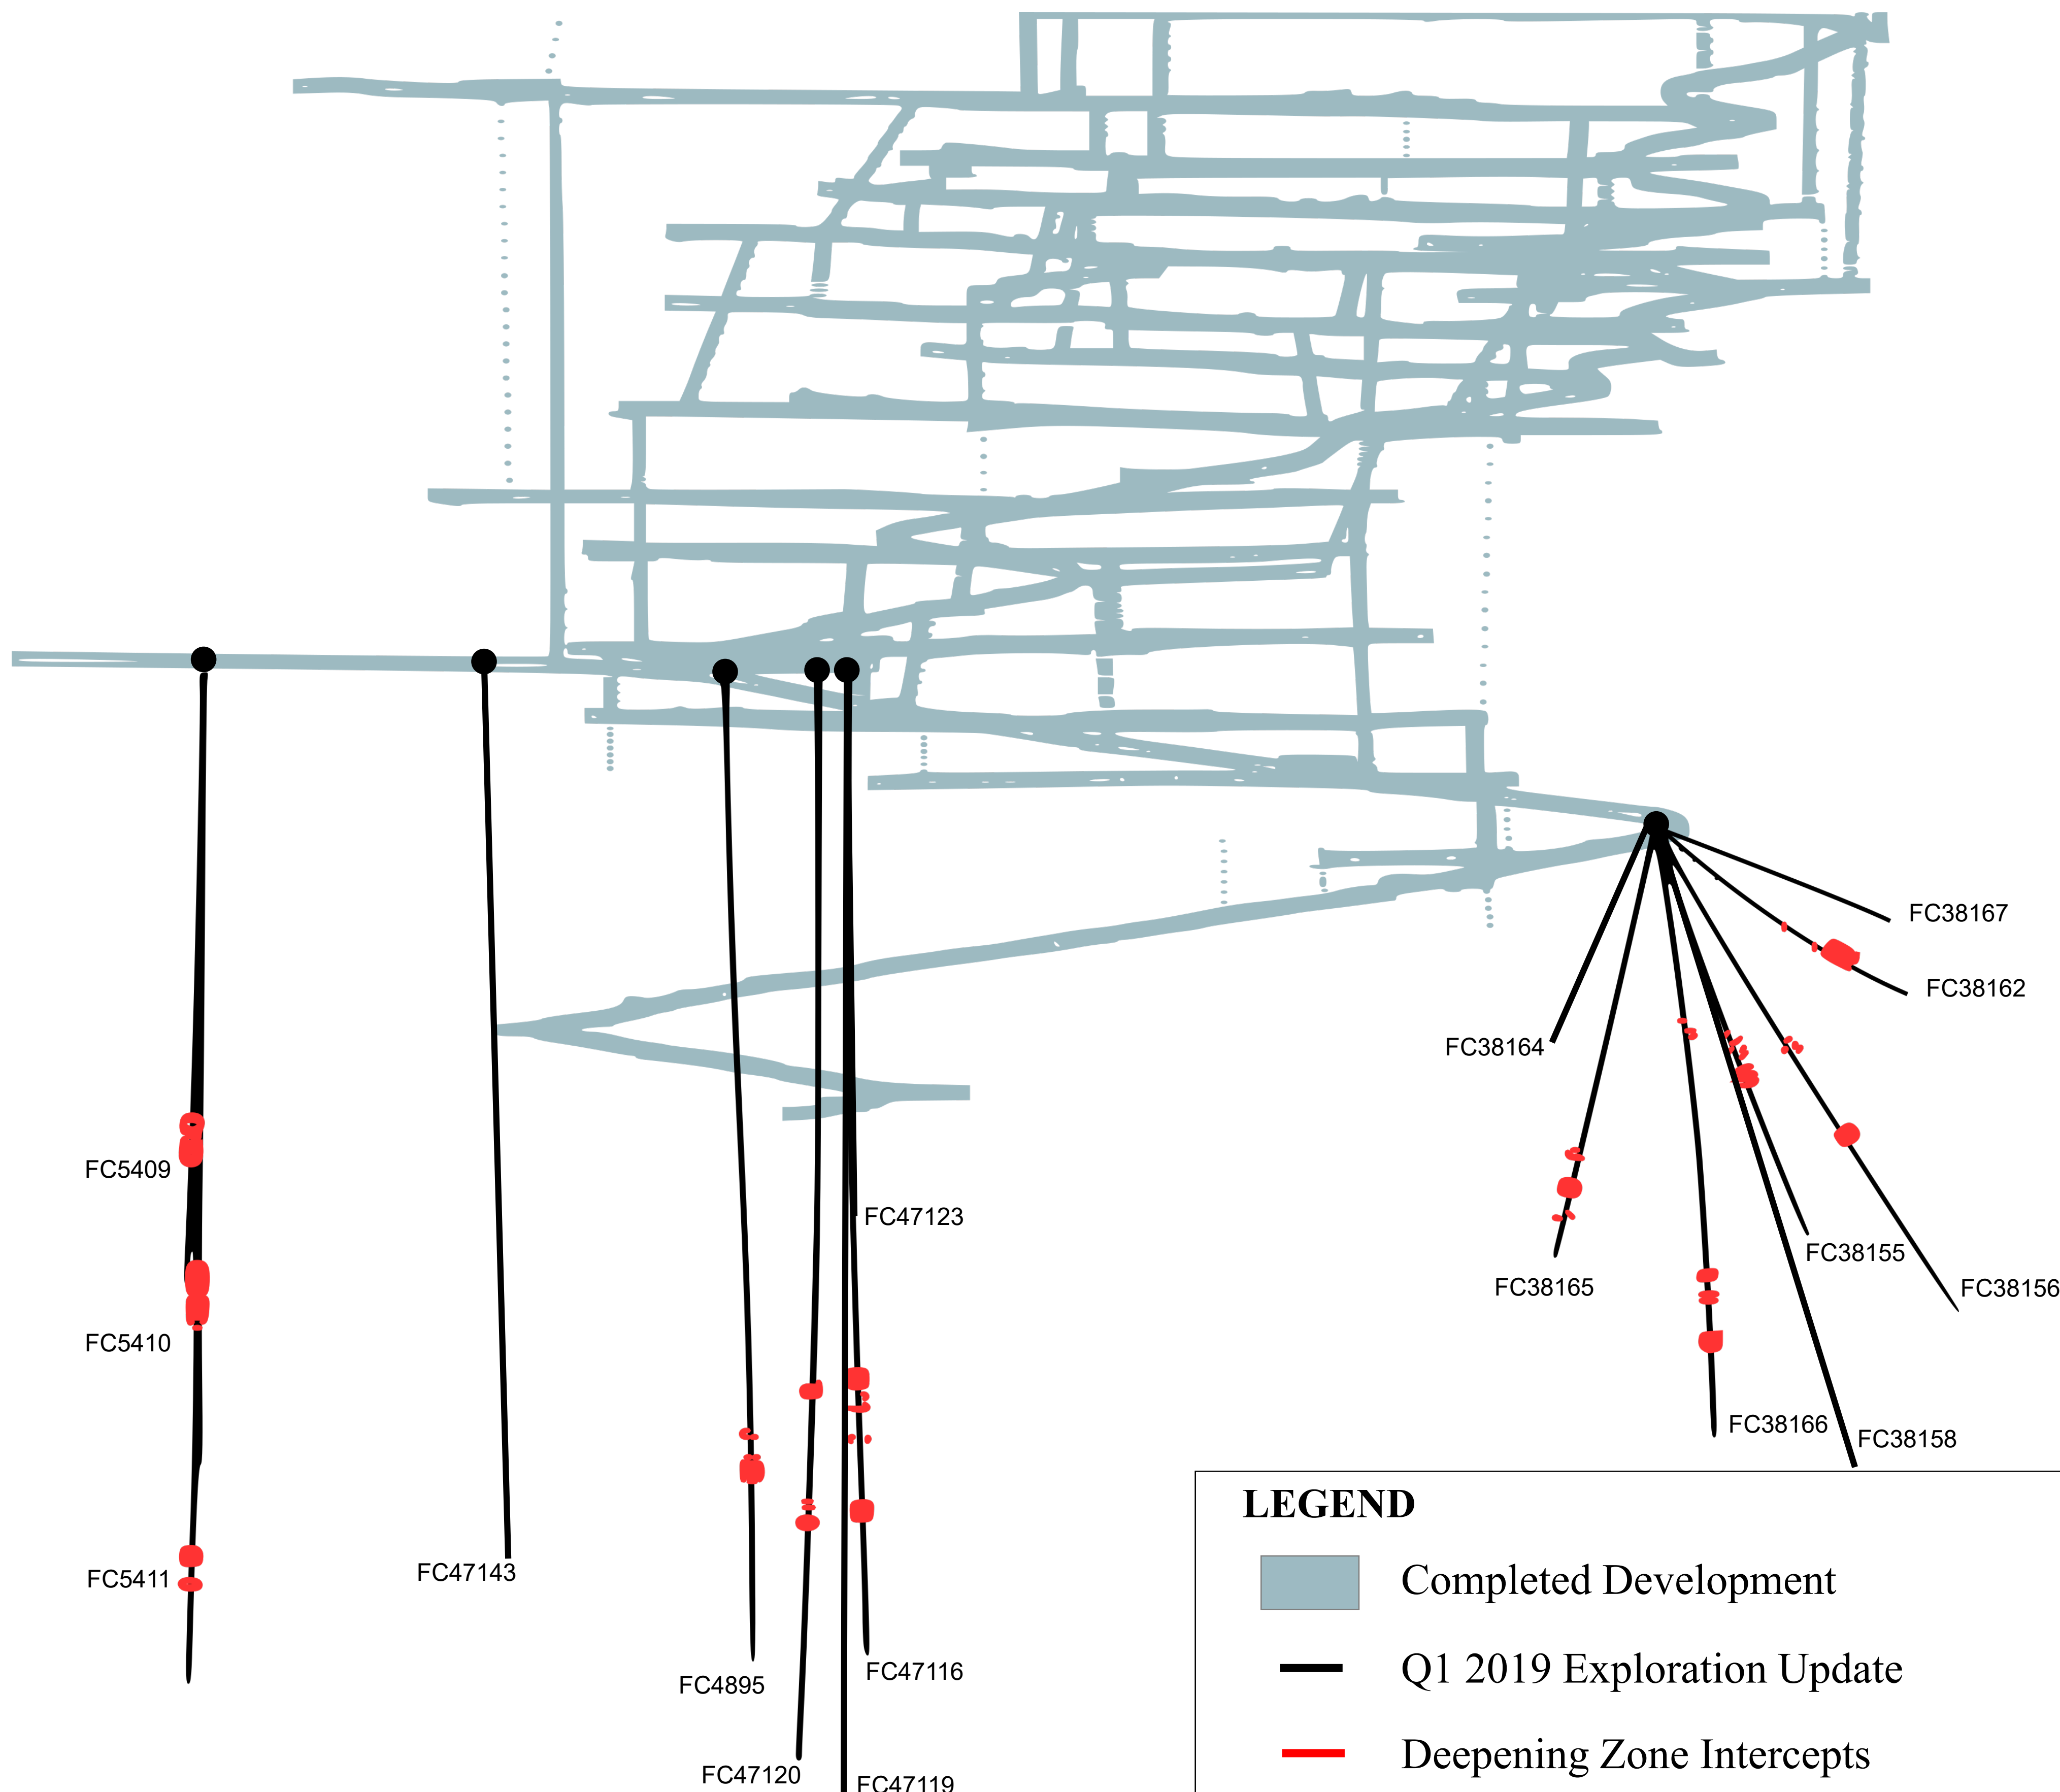
Figure 4

Deepening Extension, North-South Long Section

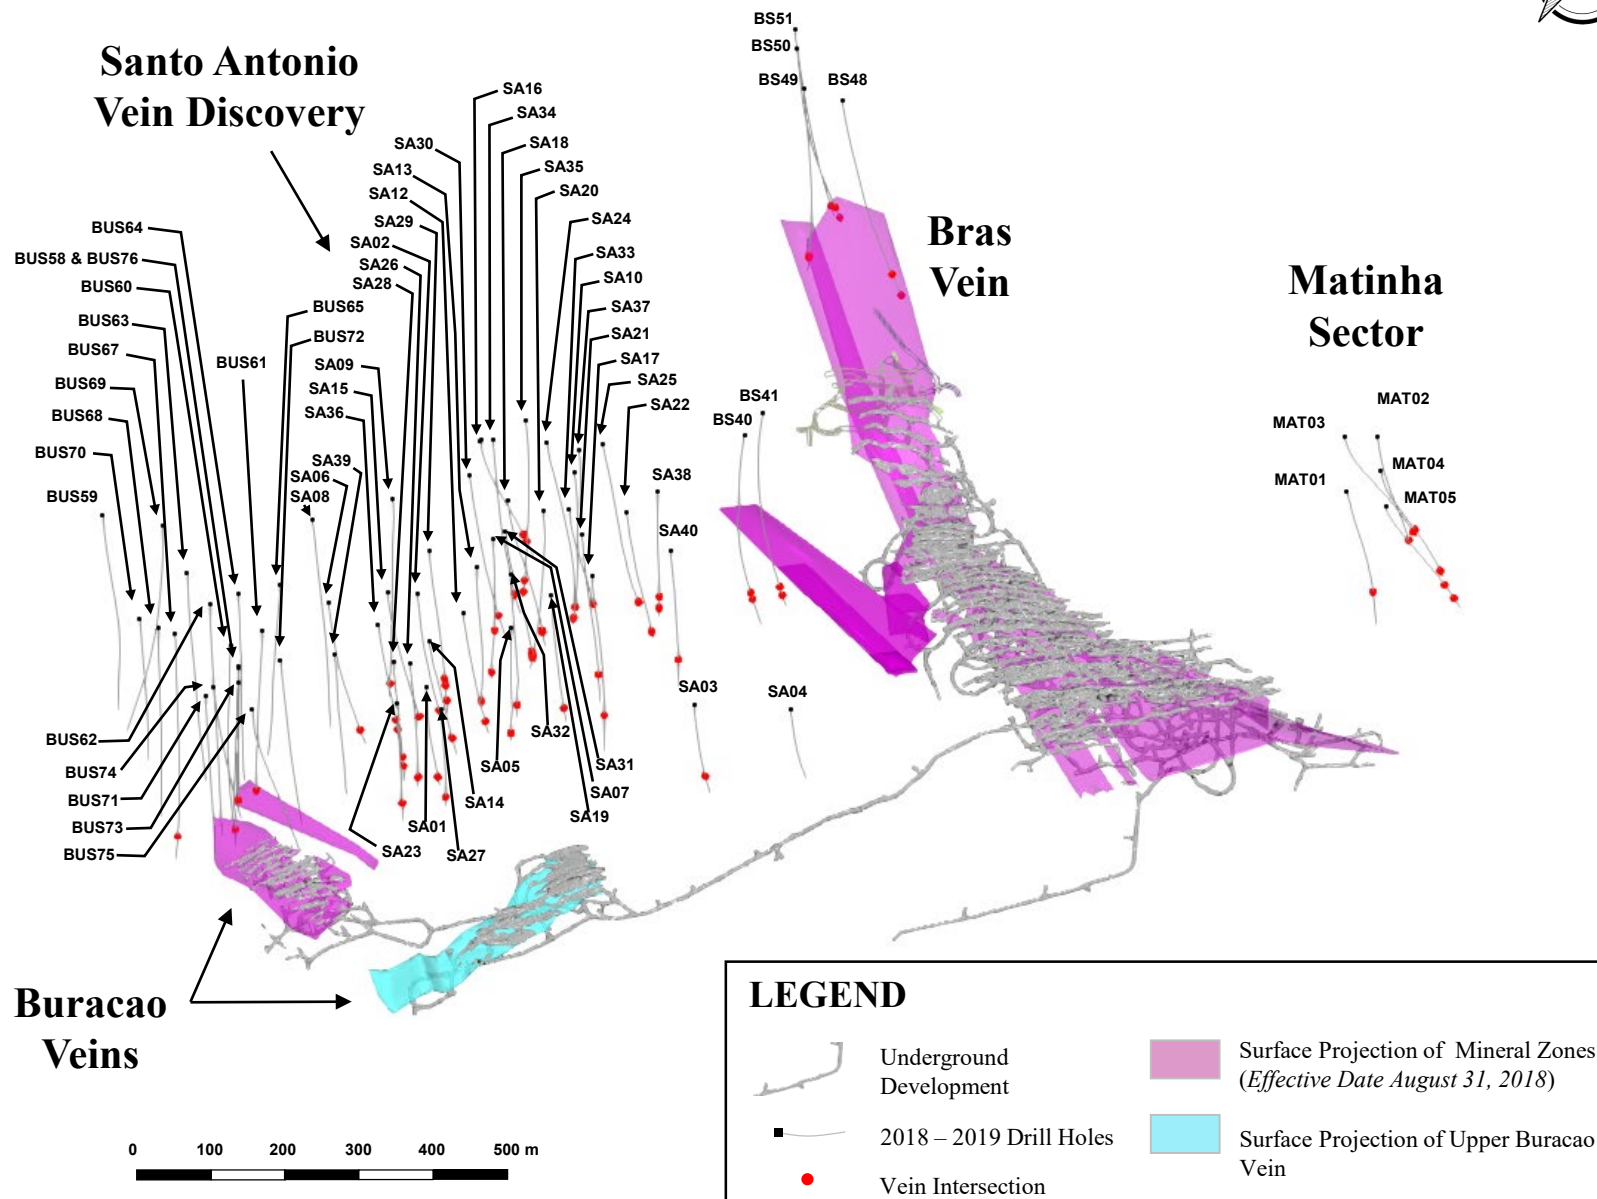
Figure 5
NX Gold Mine, Plan View

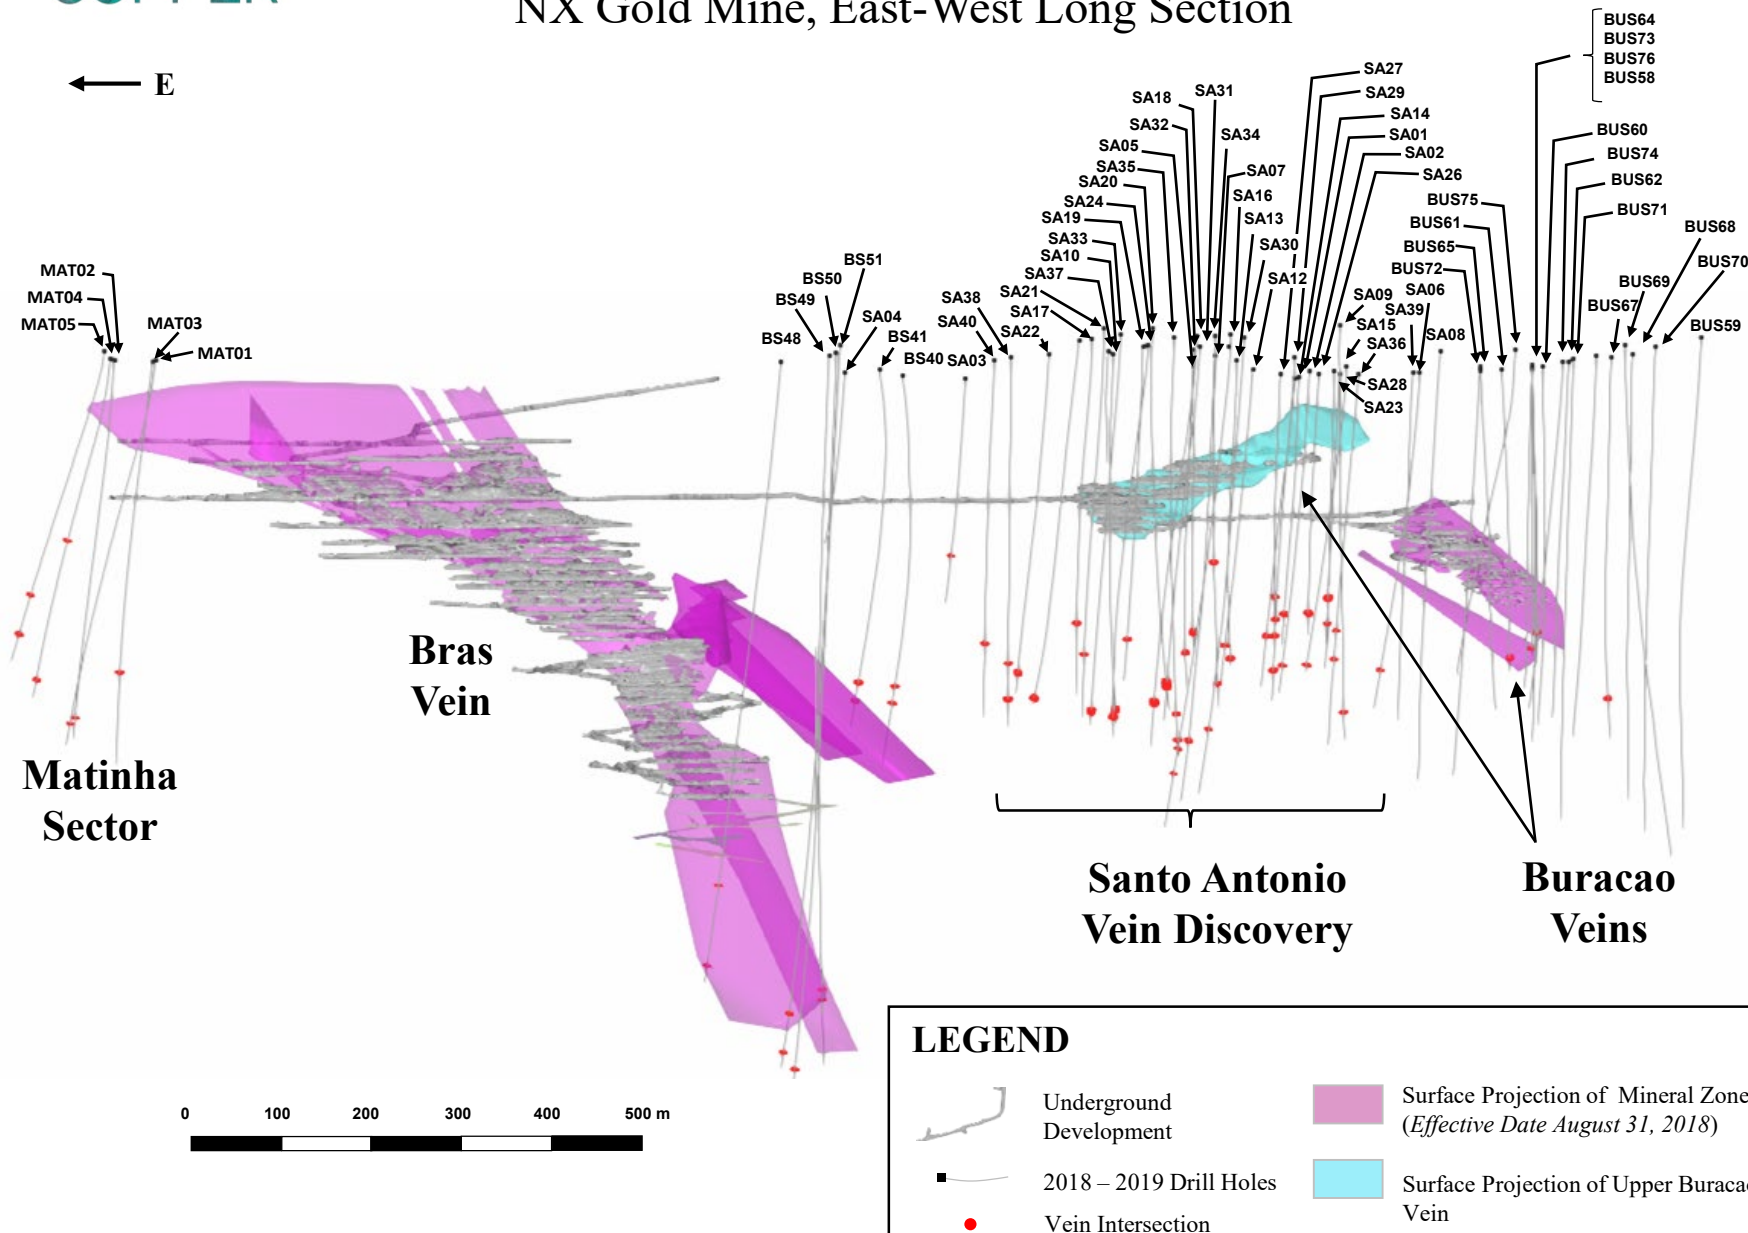
Figure 6
NX Gold Mine, East-West Long Section
