Pilar Mine, Deepening Extension

Q2 2020 Exploration Update

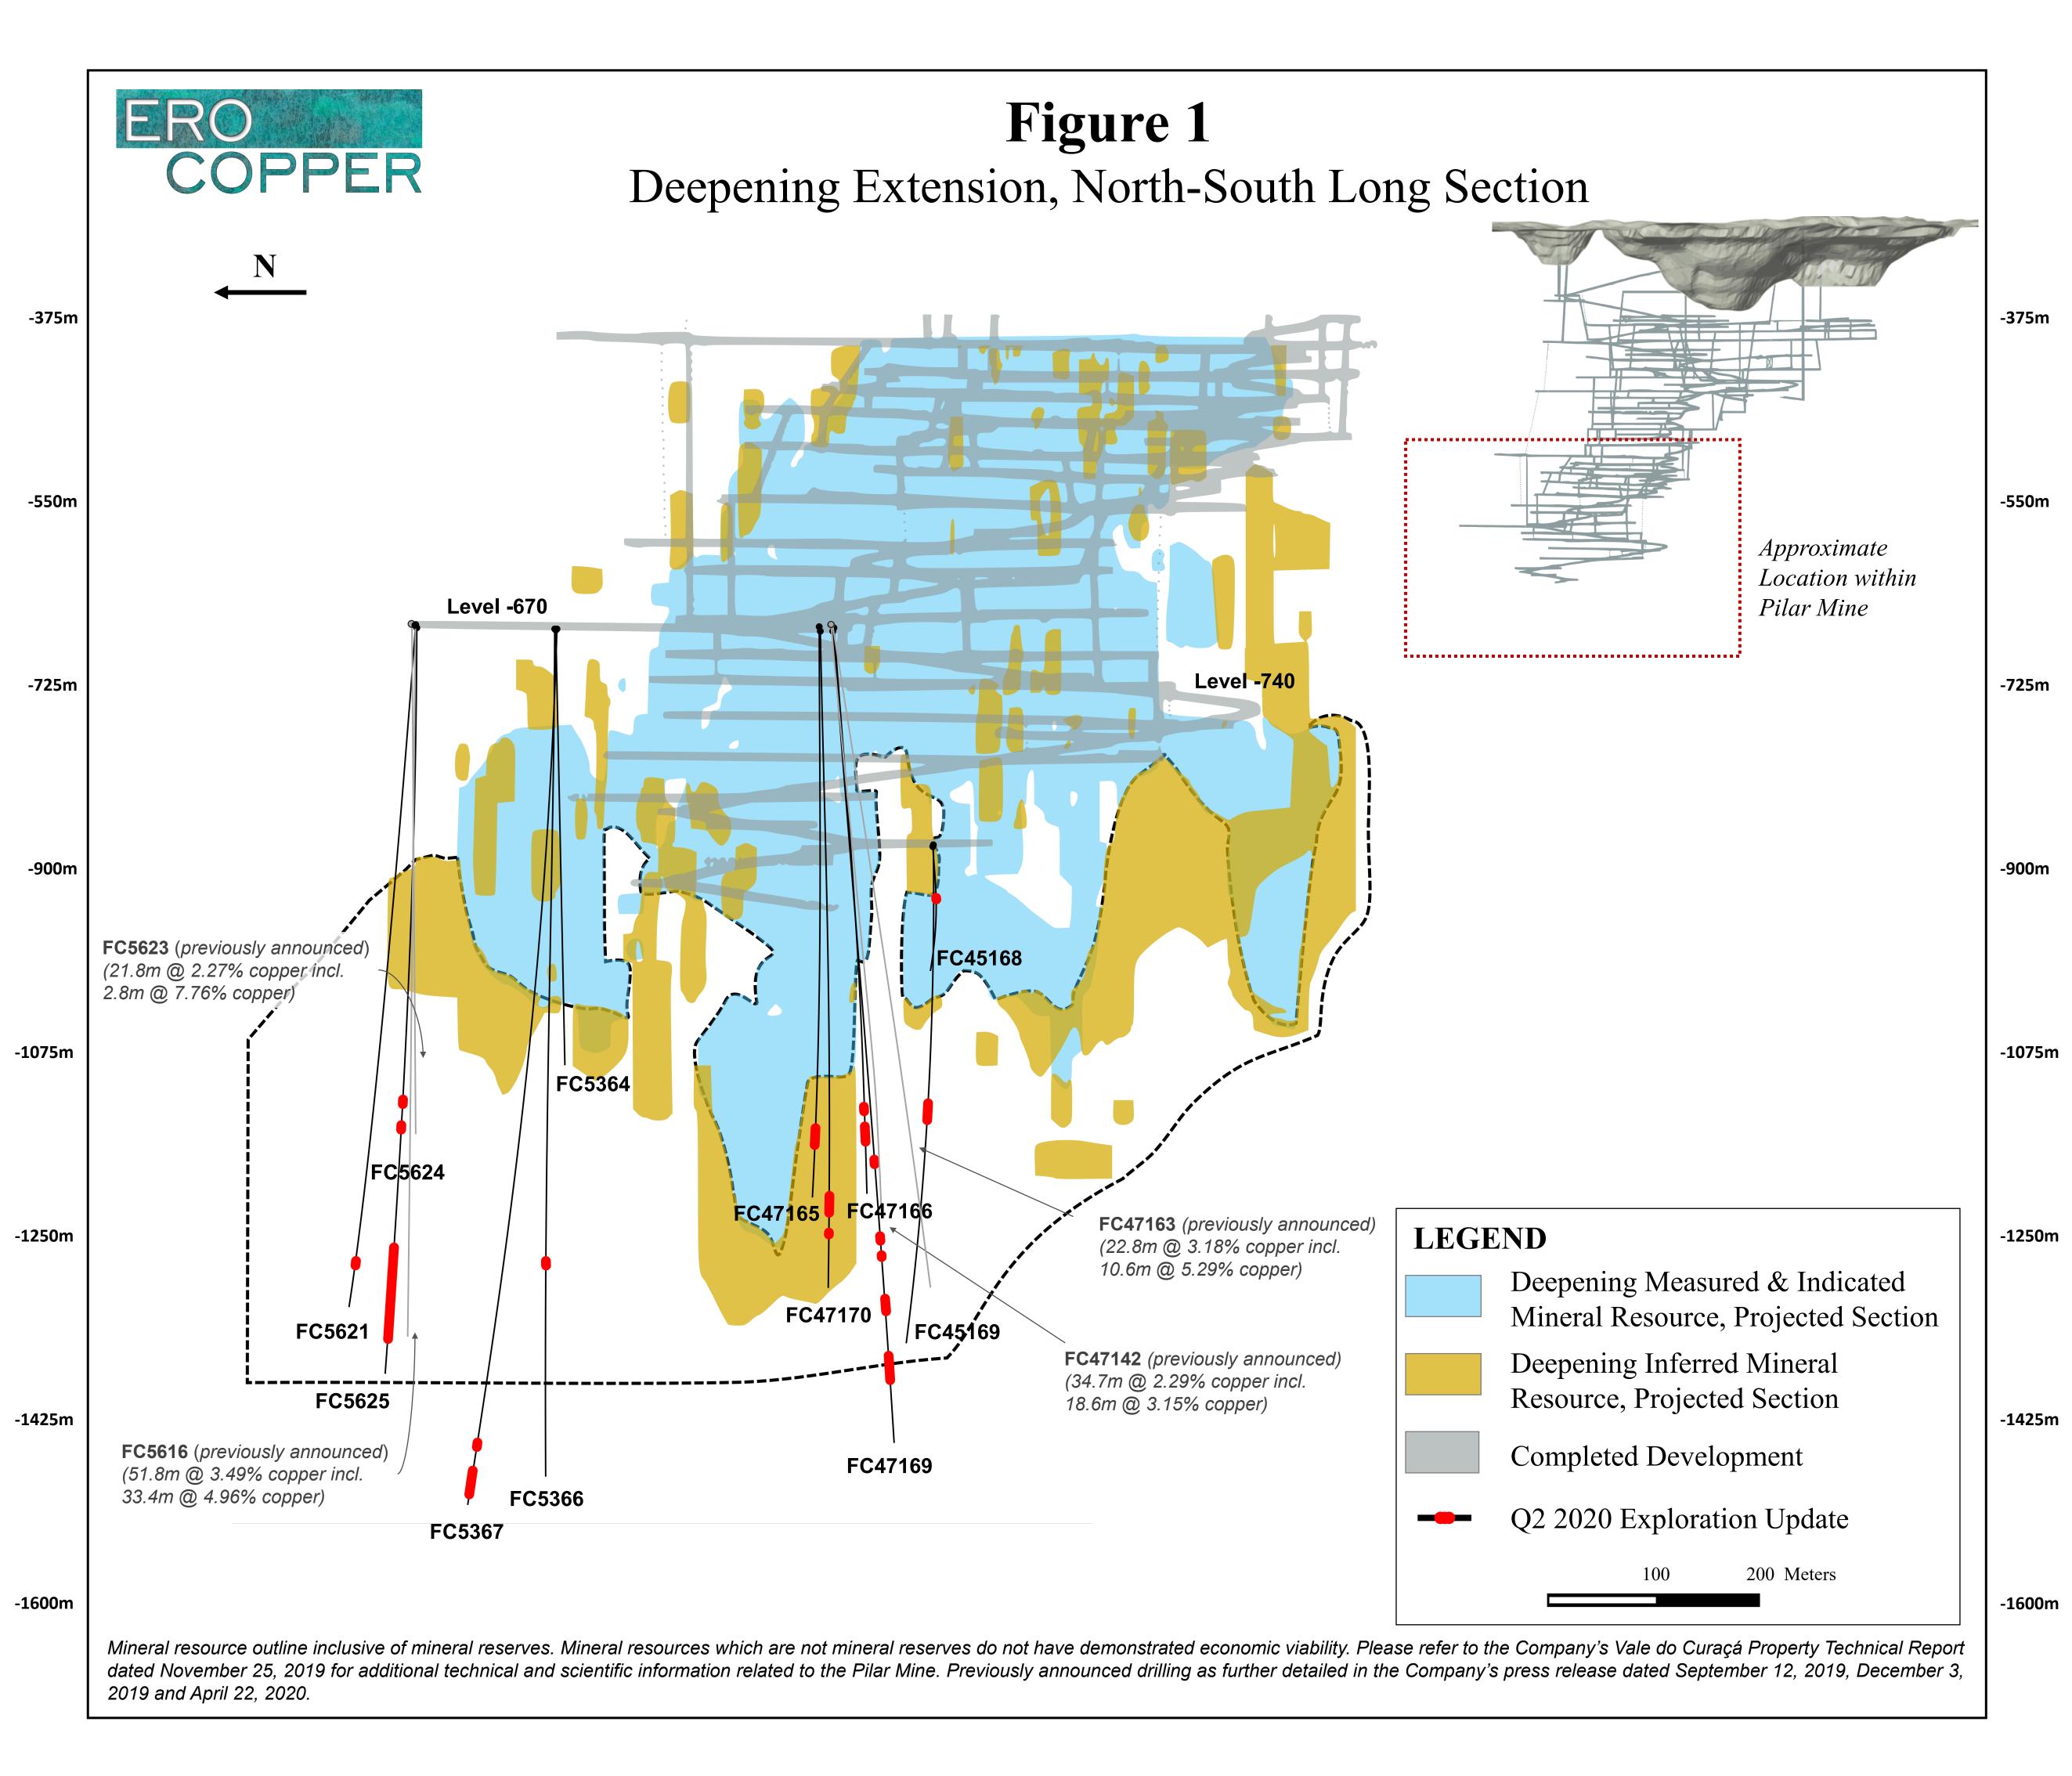
Figure 2

(Drilling From Level -670 and -740)

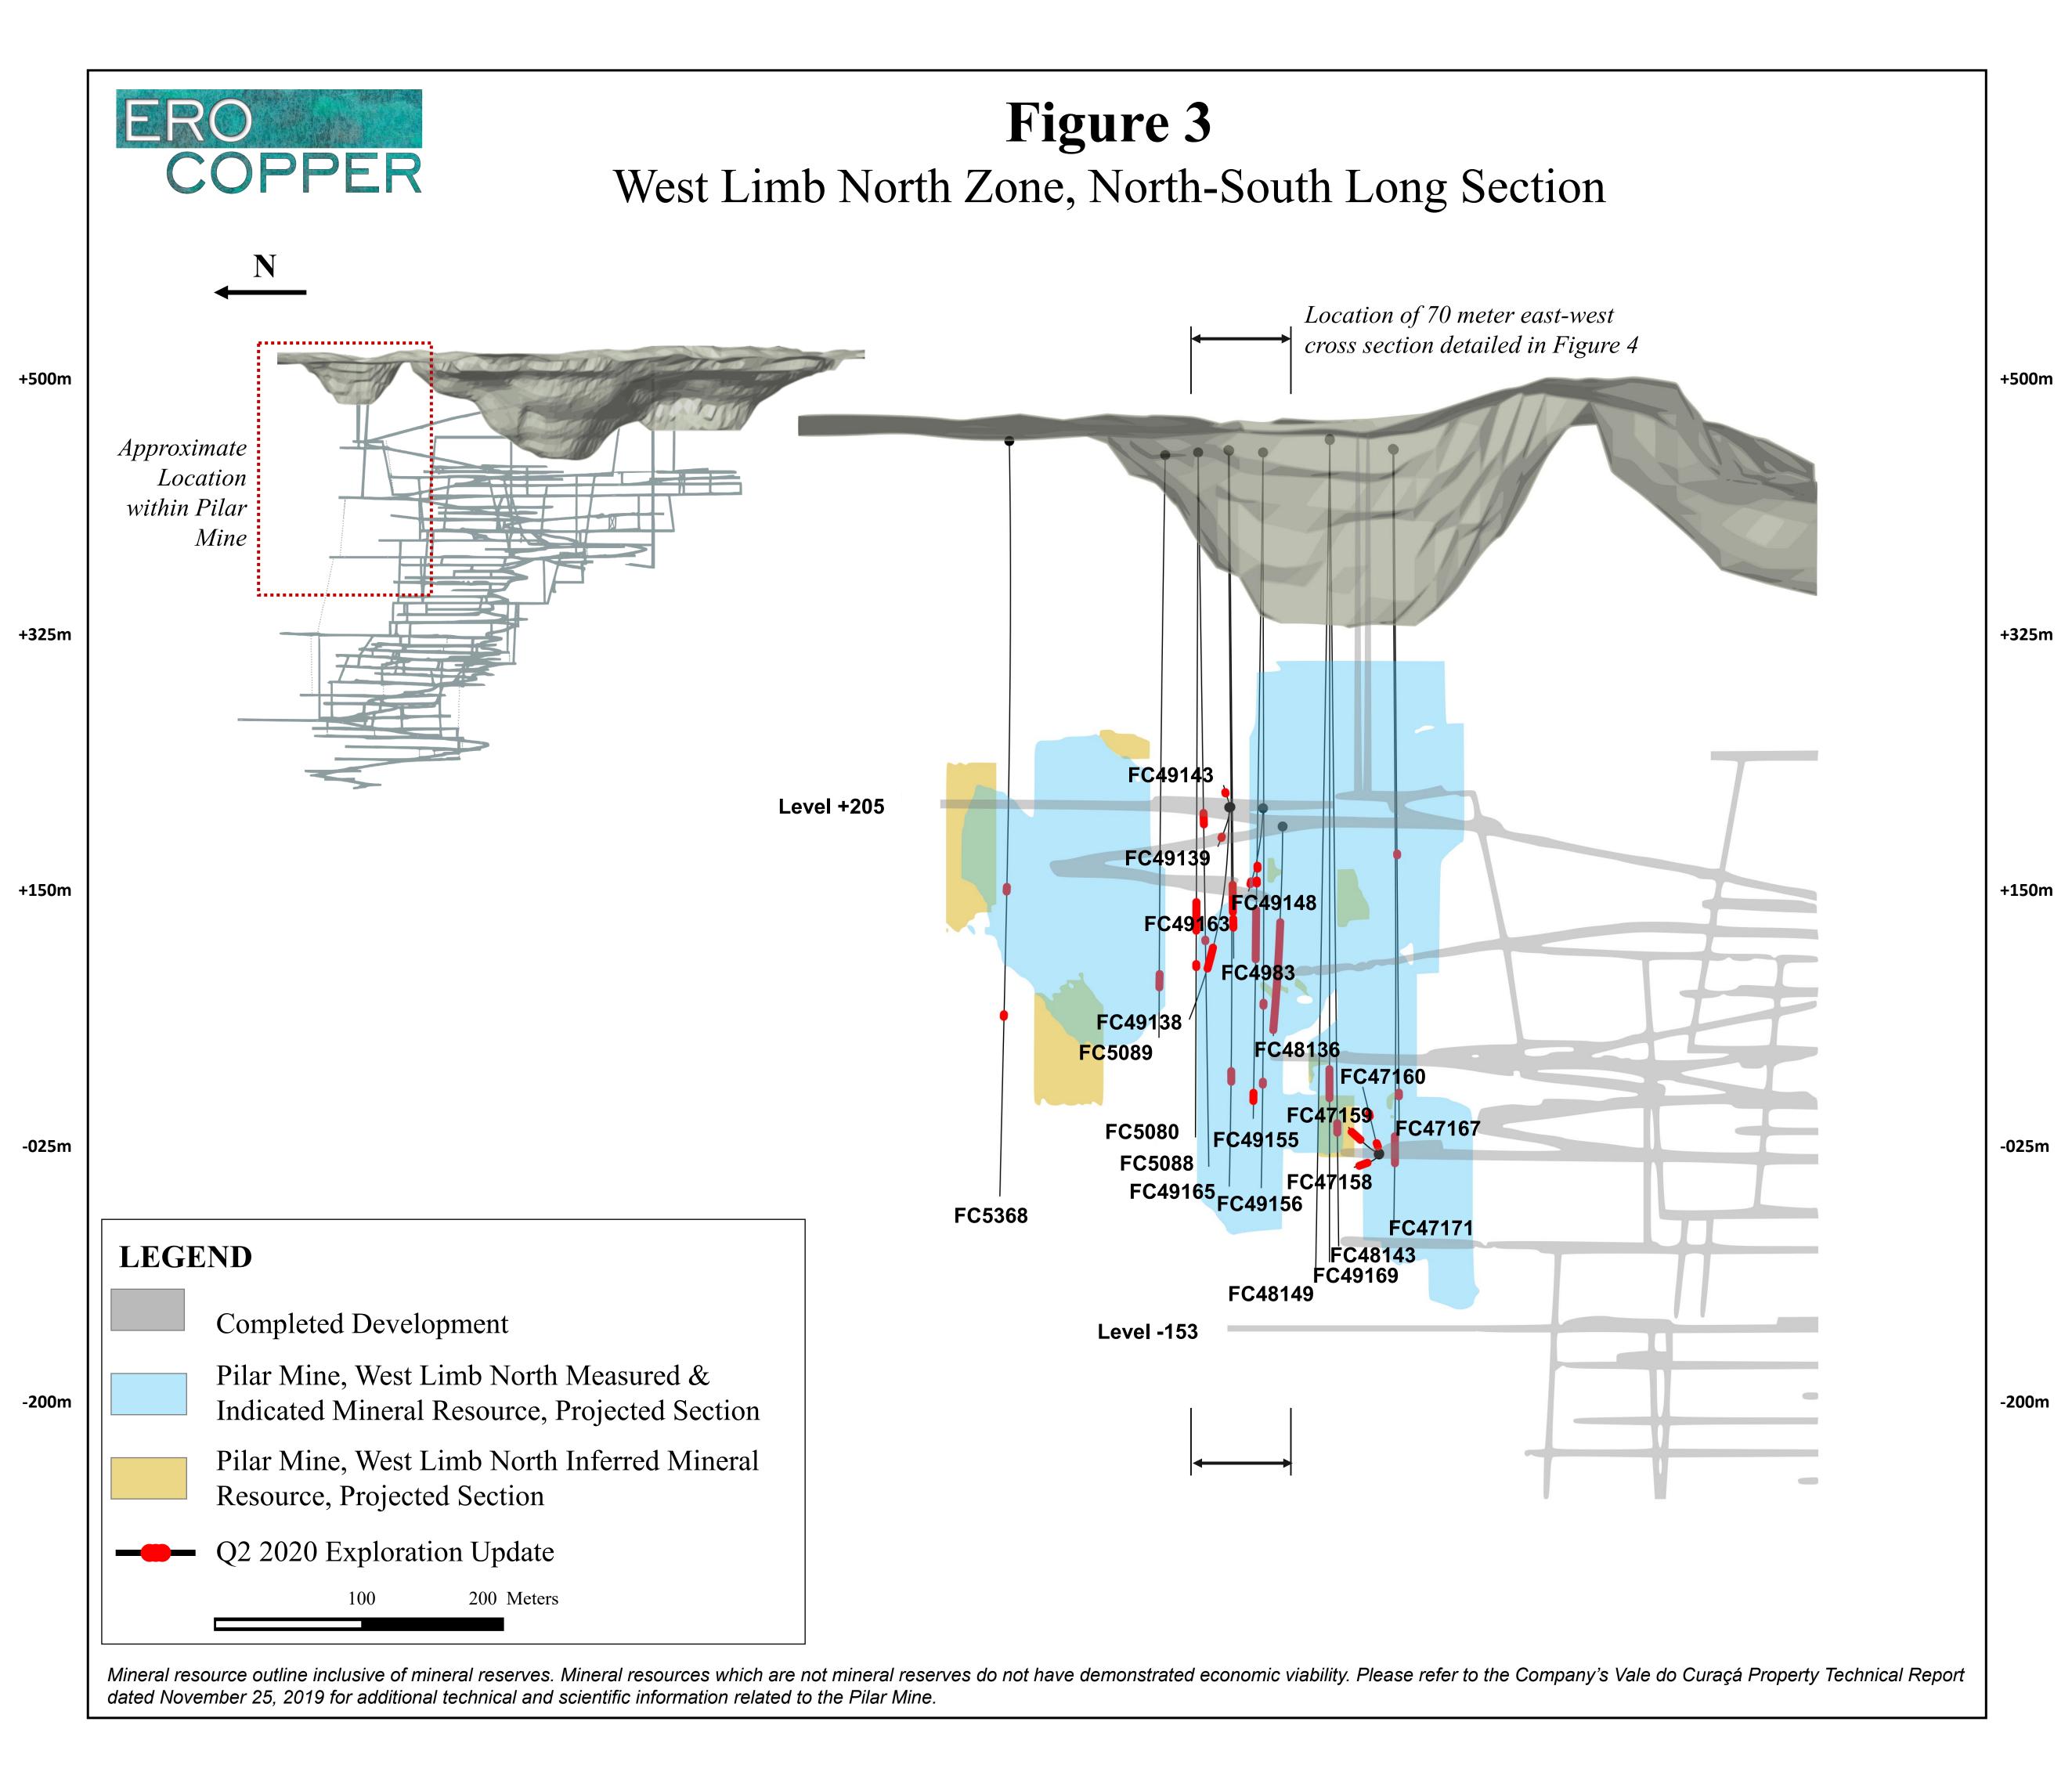
Figure 4

West Limb North Zone, East-West Cross Section

(View looking North)

Pilar Mine, West Limb North Measured & Indicated Mineral Resource, Projected Section

Pilar Mine, West Limb North Inferred Mineral Resource, Projected Section

Mineral resource outline inclusive of mineral reserves. Mineral resources which are not mineral reserves do not have demonstrated economic viability. Please refer to the Company's Vale do Curaçá Property Technical Report dated November 25, 2019 for additional technical and scientific information related to the Pilar Mine.

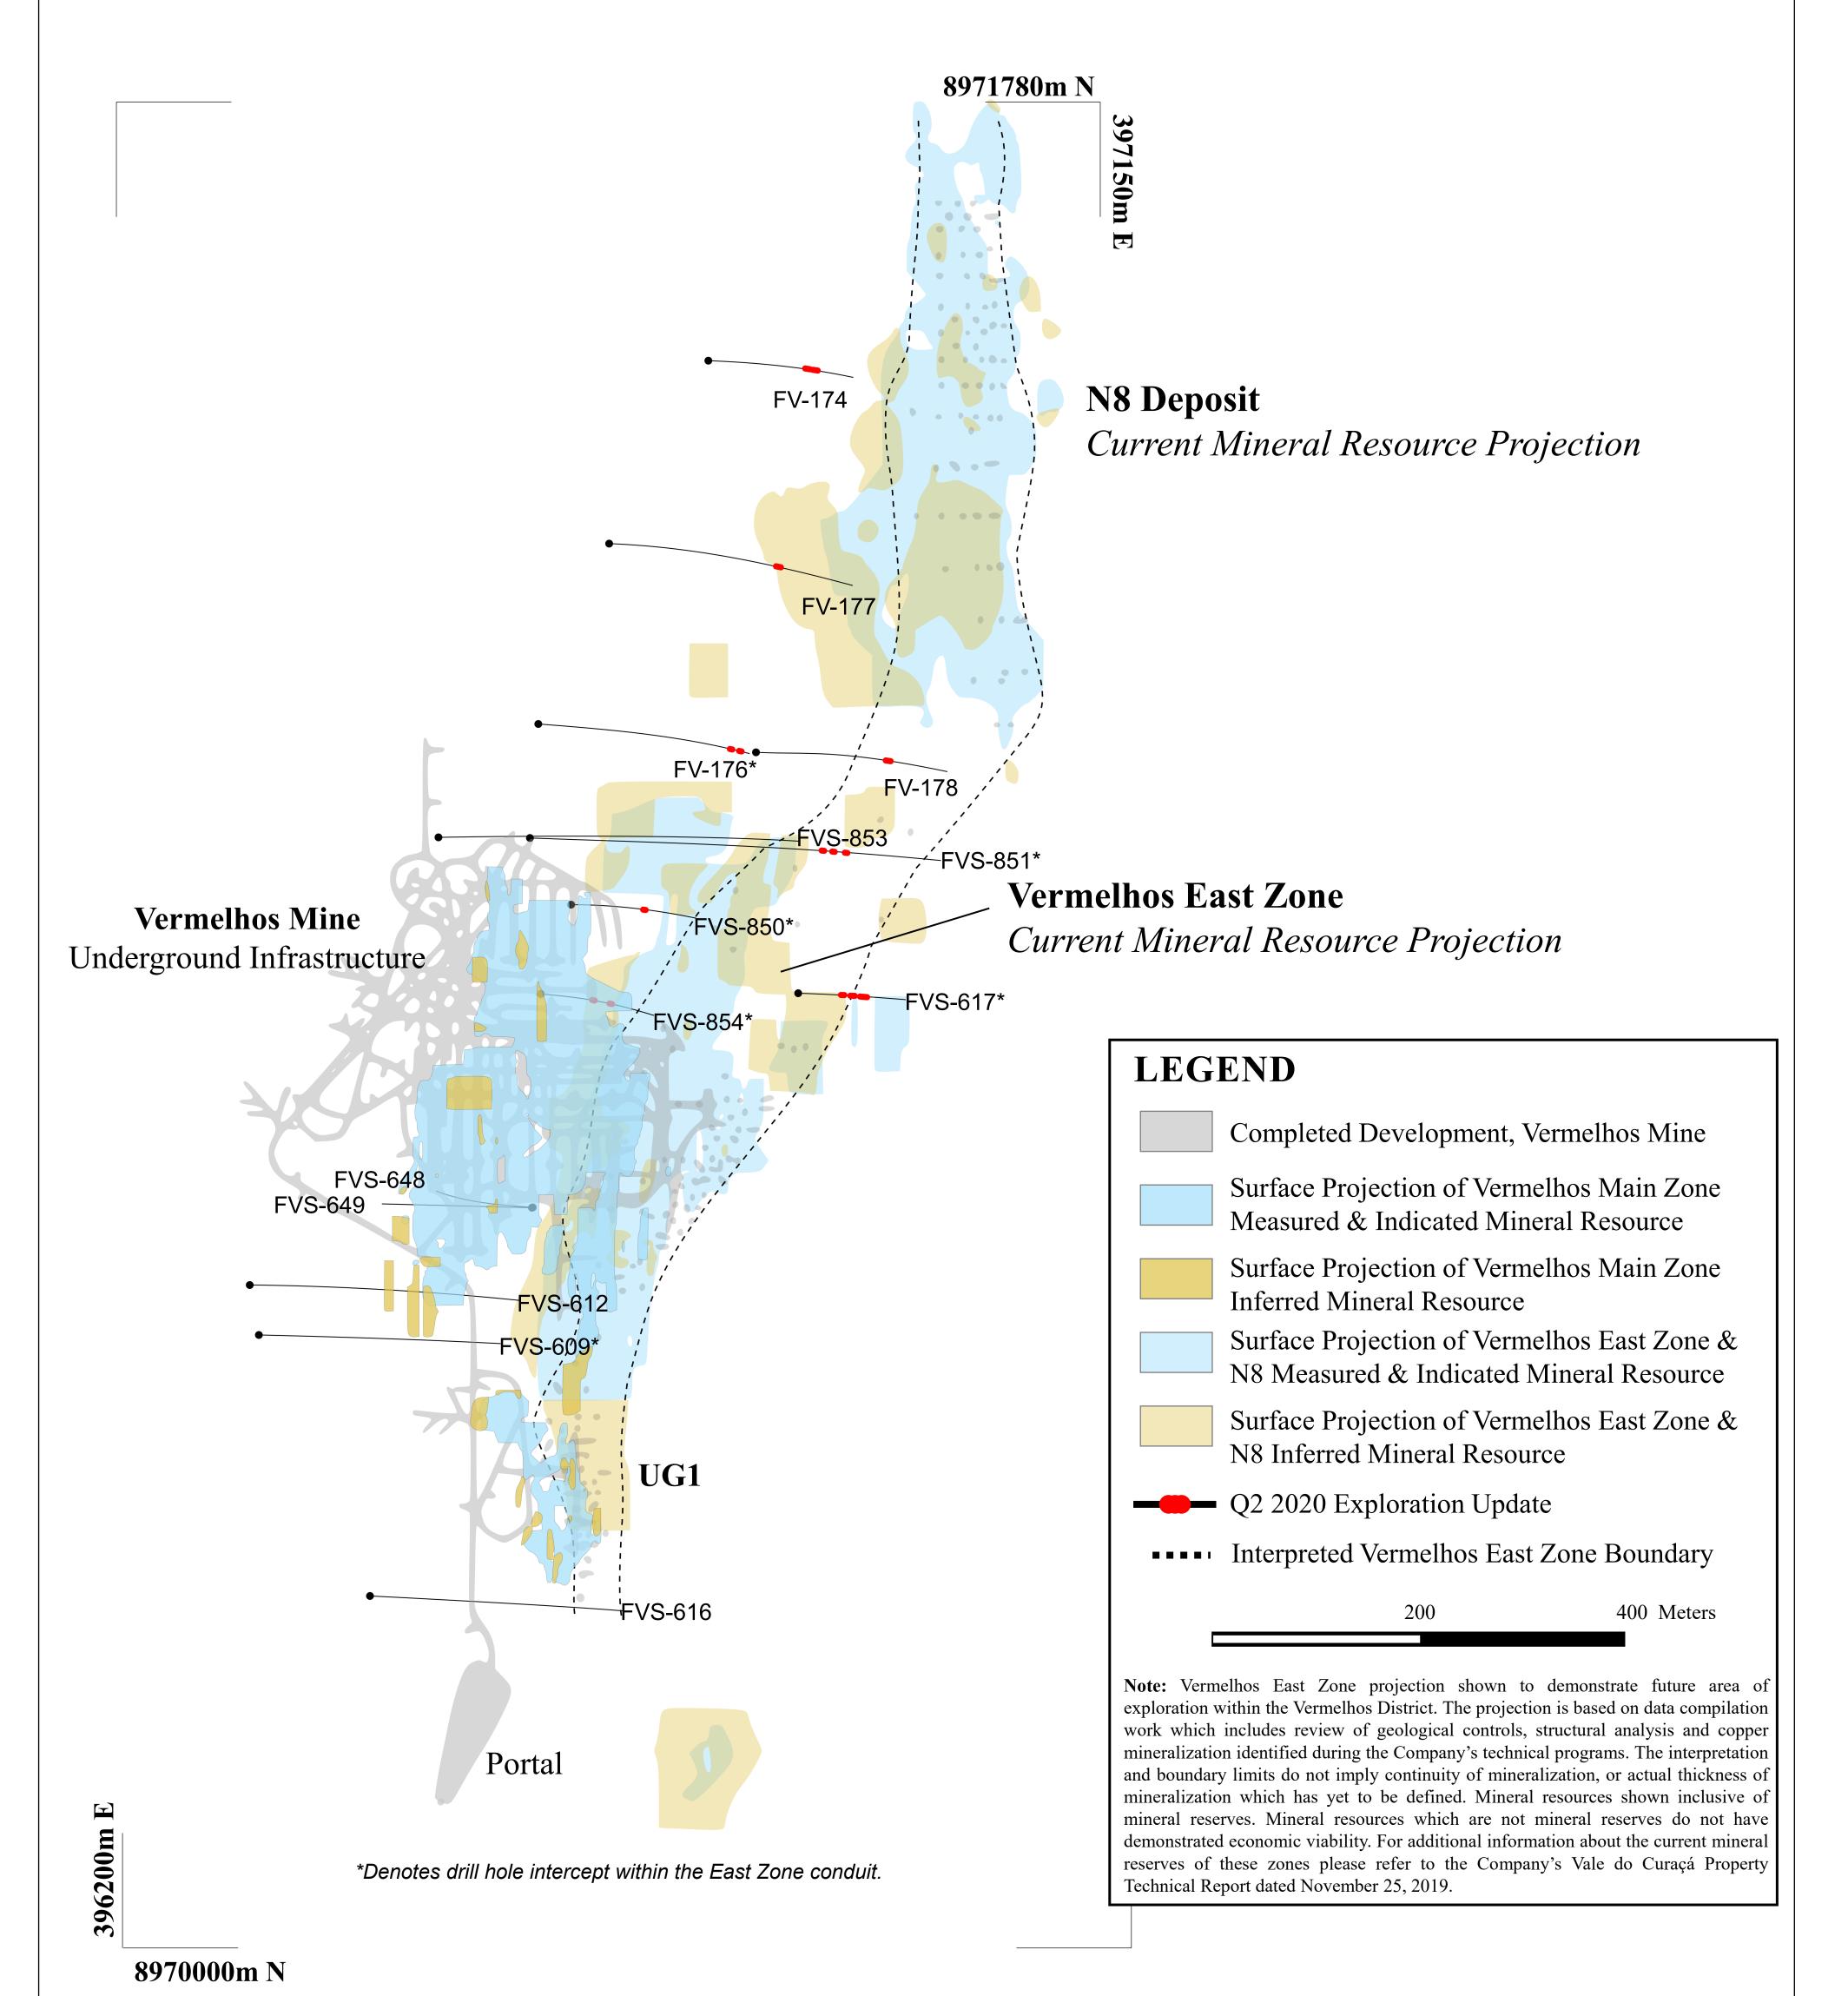
Figure 9

Vermelhos Main/East Zone & N8 Deposit, North-South Long Section
